## Safety Inspection Report

On behalf of: Freestyle Skateparks  
Site Name: Croxley Green Skatepark  
Date of Inspection: 22 August 2014  
Inspector: David Yearley

This report has been commissioned by Freestyle Skateparks to assess the condition and safety of the existing skatepark at Croxley Green.

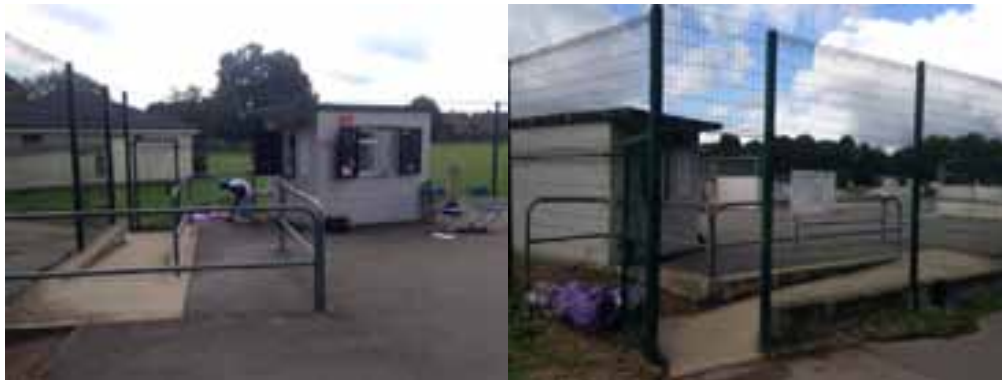
The entrance is in good condition. **LOW risk.**

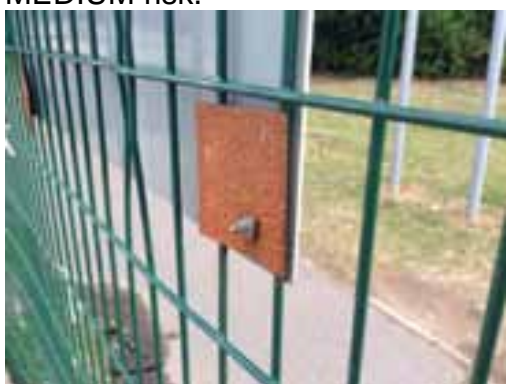
There are bolts protruding to the back of the sign to the right of the gate. Cut off the bolts flush with the nuts, and file down to remove sharp edges.

**MEDIUM risk.**

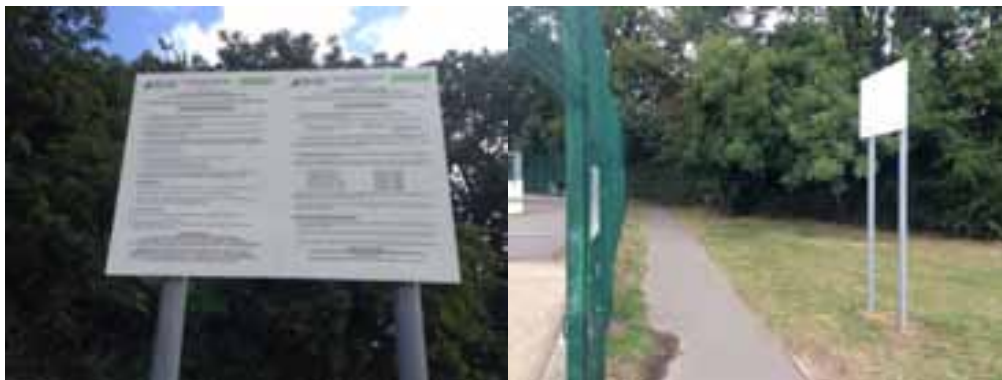
Detailed signage is provided outside the entrance gate. This is in a position where it is not likely to be read.

Consider adding signage at eye level at or near the entrance that contains the essential information, perhaps also with a reference to the main signage.

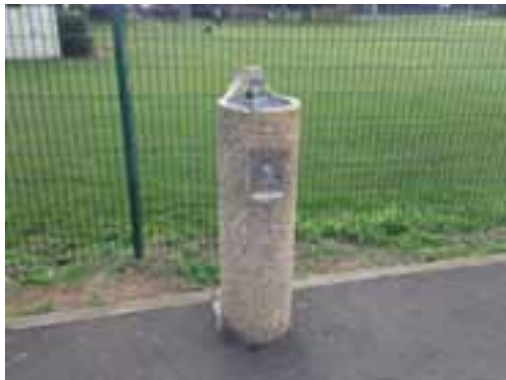
This is in good condition. **LOW RISK**

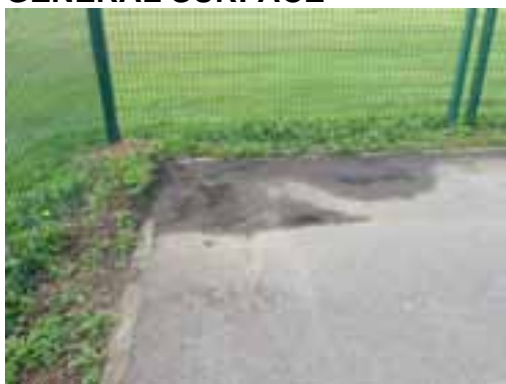
The general surface is laid to bitumen macadam (tarmac). This is not an ideal choice for skateboard riding due to the particle size of the macadam, the undulating nature of the surface and the tendency for water to pool. Consideration should be given to installing drainage to the site to alleviate the water pooling that is present.

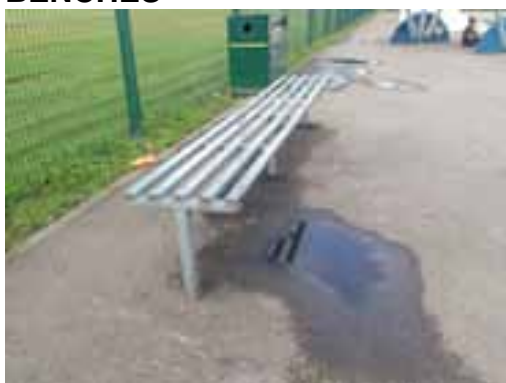
The benches are in good condition. They are rideable benches, that show evidence of riding/grinding.  
**HIGH risk (due to their rideability)**

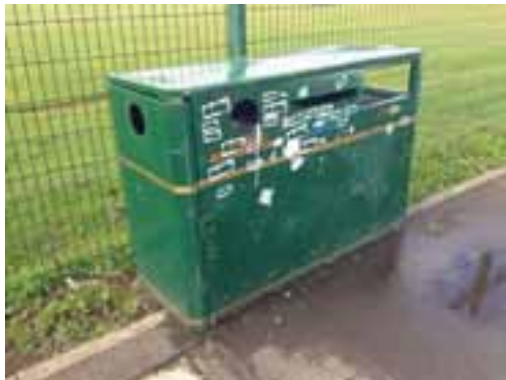
The bins are in fair condition. They show signs of riding/grinding, which will require monitoring to ensure they remain in satisfactory condition.  
LOW risk.

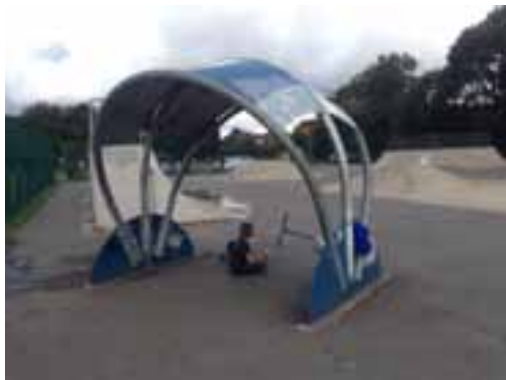
The shelter is in good condition.  
LOW risk.

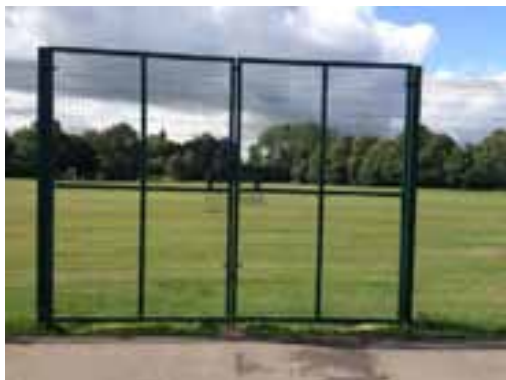
These are in good condition and present a LOW risk to users.  
Monitor the fence nearest to the bin adjacent to the footpath as it is being struck by riders grinding the bin/seat.

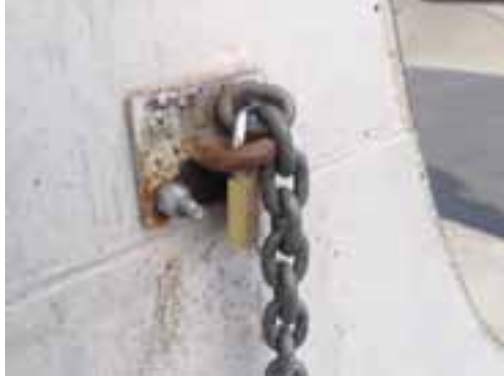
The chain connector to one end has protruding bolts. Cut off and file down to remove sharp edges. MEDIUM risk.

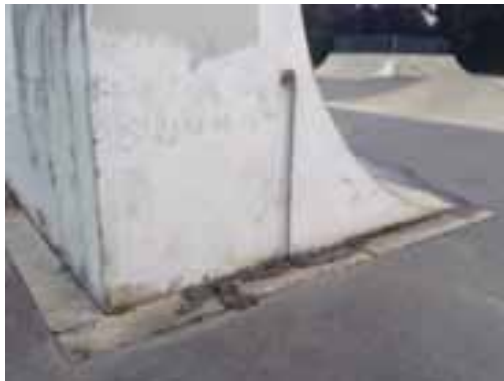
Chains are left to the sides of the unit. These would be better stored away from each unit when the ramps are open to avoid tripping potential. This applies to all chains on site.

LOW risk.

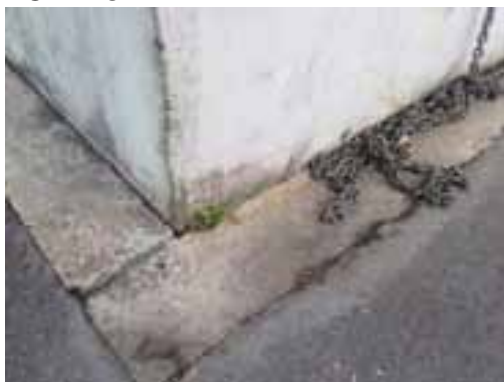
The unit is subsiding. This may cause increased distortion and uneven riding surfaces.

LOW risk.

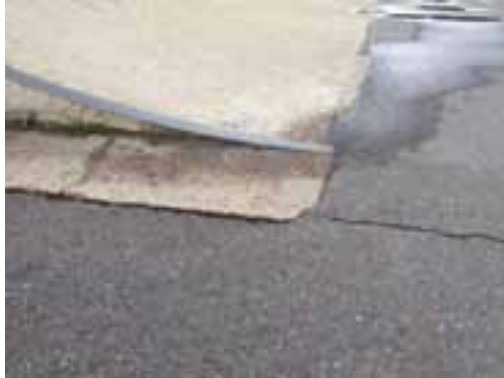
The foot has concrete edges/filler which will lift and cause uneven riding surfaces. Rectification is not reasonably practicable without considerable remedial work. Monitor for deterioration and repair as necessary.

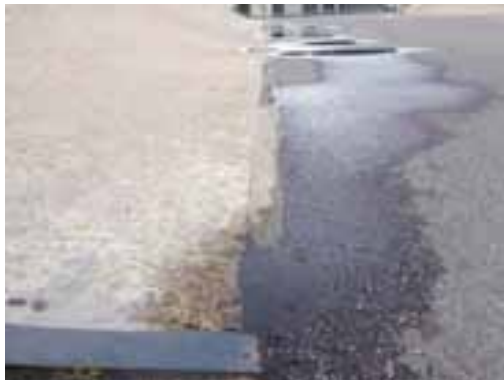
There is considerable water pooling at the foot of the unit, along its length. This is only practically rectified by resurfacing. **MEDIUM** risk.

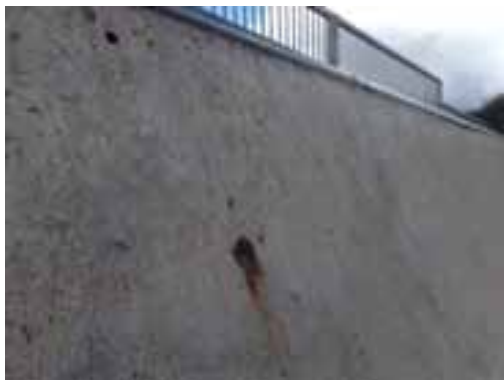
The metal bars within the concrete are showing, with corroded ends. This indicates that the wear to the concrete surface puts the unit towards the ends of its life expectancy. This applies to all units on site. **LOW** risk.

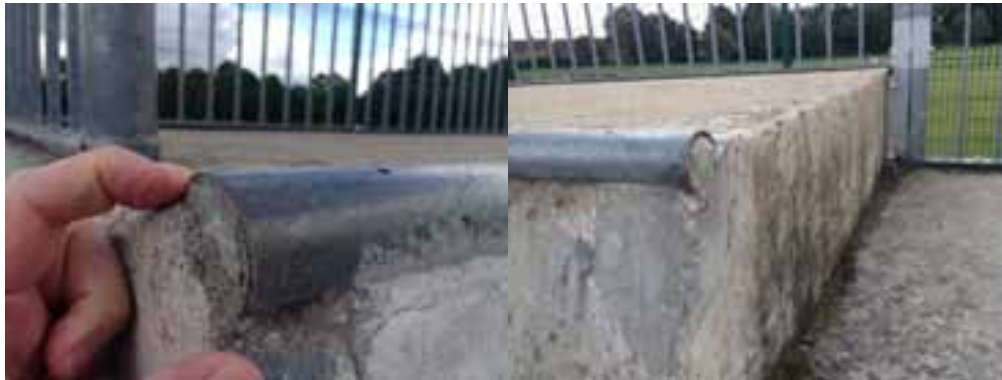
The coping ends are not rounded with a radius of minimum 3 mm.  
MEDIUM risk.

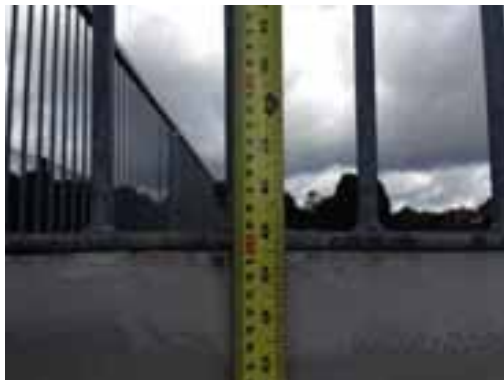
The barriers are less than the required 1200 mm high.  
LOW risk.

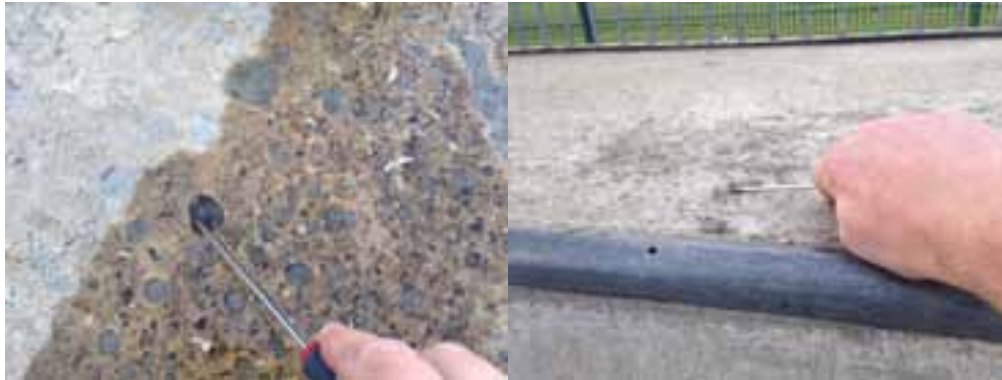
There are holes in the concrete at various points. These create uneven riding surfaces and will lead to further deterioration, especially through frost action.  
MEDIUM risk.

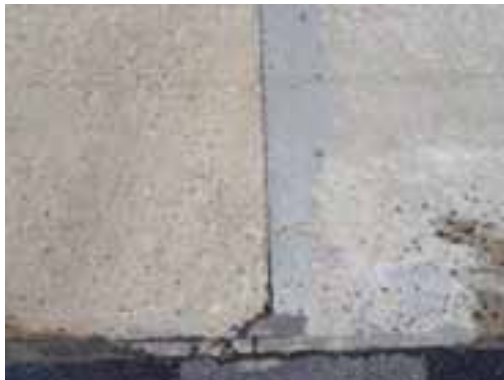
The repair at the base of one section is cracked, which will lead to uneven riding surface.  
MEDIUM risk.

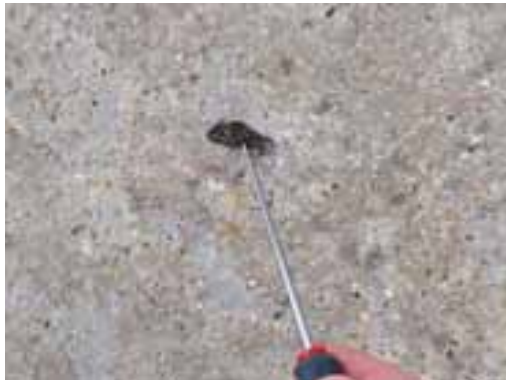
Timber fragment is showing in the concrete, indicating a poor concrete mix. More generally, the concrete presents a rough surface to riders, making riding difficult and falls potentially more painful than necessary. This applies to all concrete on site.

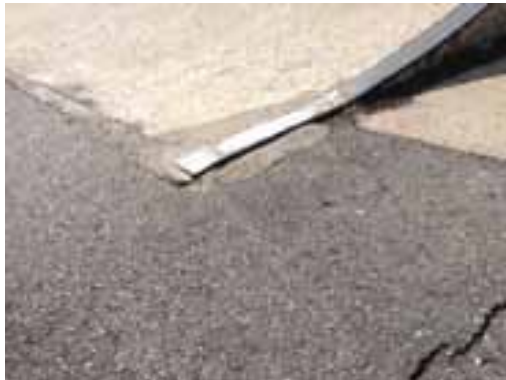
The metal corner plate protrudes creating a tripping point and uneven riding surface.  
HIGH risk.

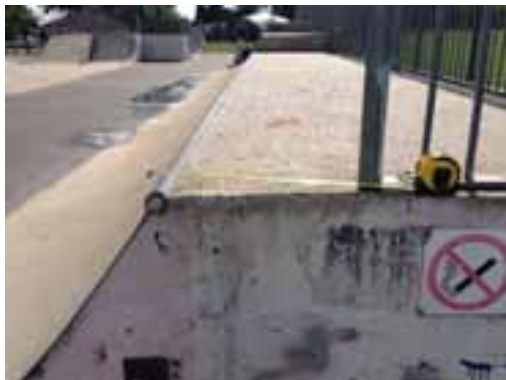
The spacing between the barrier front and the coping is excessive.  
LOW risk.

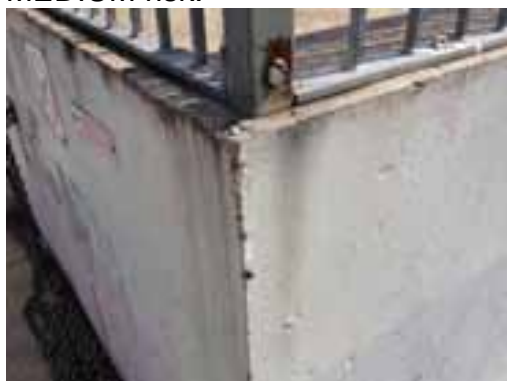
The concrete edges are sharp, without a minimum of 3 mm radius.  
MEDIUM risk.

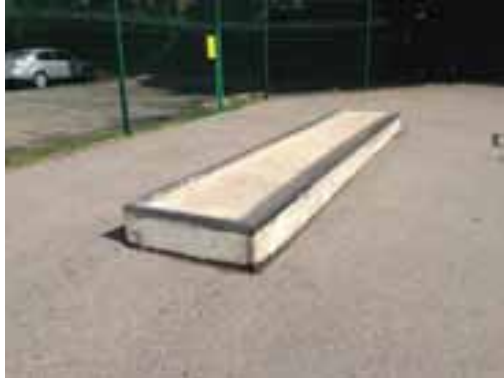
The rail is in good condition. It presents a HIGH risk due to the nature of the sport.

The rail ends are not rounded contrary to EN 14974, but the non-rounded rails provide a better riding experience and do not require modification.

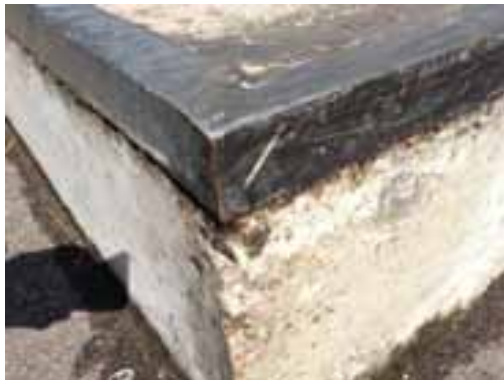
This is in fair condition and presents a HIGH risk to users due to the nature of the sport.

The ends have non-rounded edges.  
HIGH risk.

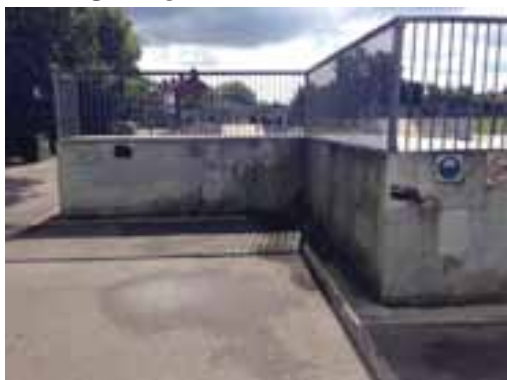
The void space behind the unit has an accumulation of debris which may find its way to the riding surfaces.

MEDIUM risk.

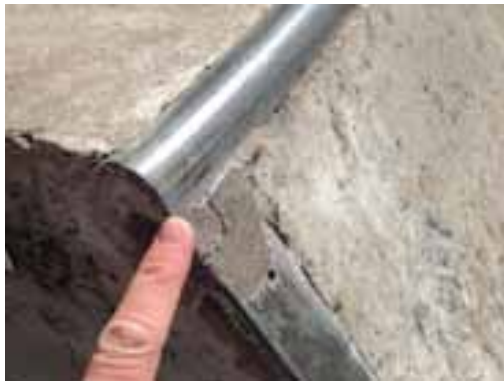
The coping ends do not have a minimum 3 mm radius.  
MEDIUM risk.

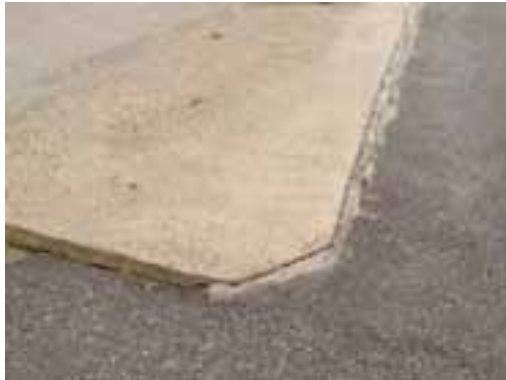
The concrete infill at the foot creates an uneven riding surface and will deteriorate to create distinct tripping points.  
MEDIUM risk.

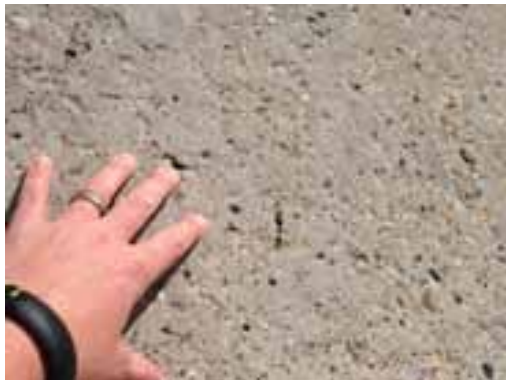
The surface of the transition is particularly rough, presenting risk of significant grazing in the event of a fall.  
MEDIUM risk.

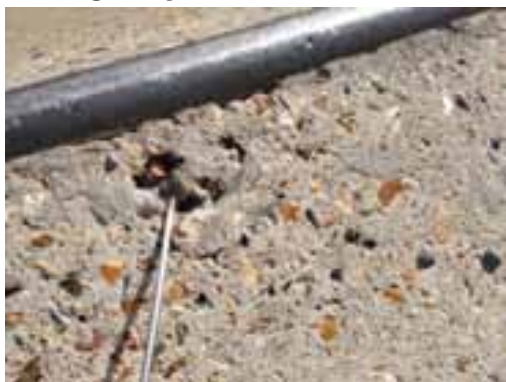
There are significant holes in the riding surface, creating an uneven surface that will deteriorate over time, especially with frost action.  
MEDIUM risk.

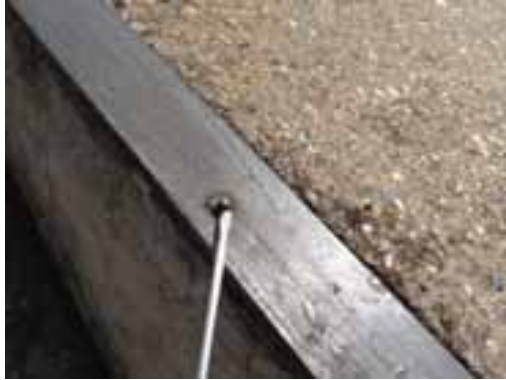
There is an upstanding bolt to the metal strip between the transition and the flat. This presents a significant body puncture/tear hazard.  
HIGH risk.

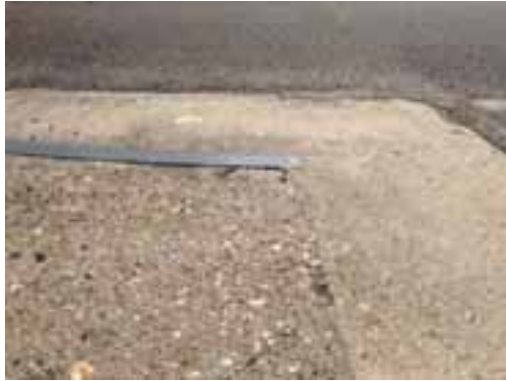
The metal edge piece protrudes, creating an uneven riding surface.  
MEDIUM risk.

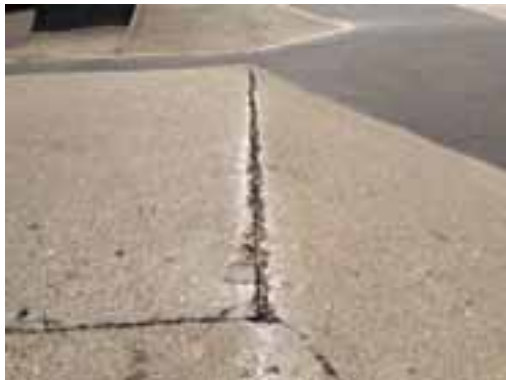
The concrete has a joint along the top of the flat, which creates an uneven riding surface and will deteriorate over time, especially with frost action.  
MEDIUM risk.

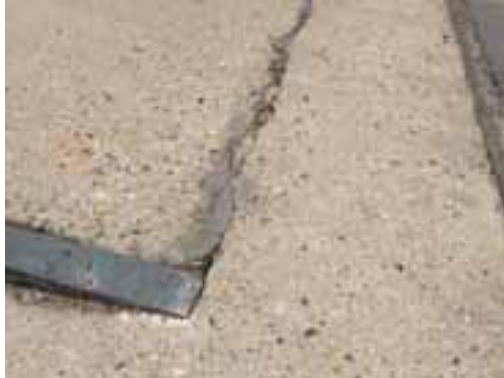
A significant crack runs along the foot of one transition, creating an uneven riding surface.  
MEDIUM risk.

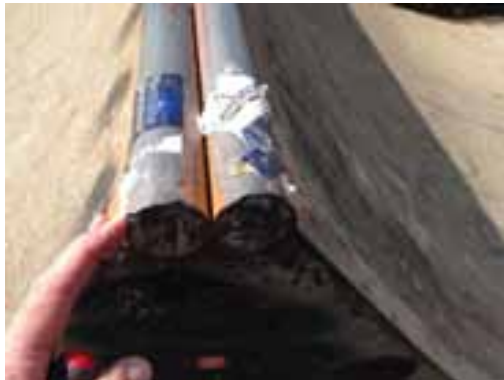
The coping ends are non-rounded and have sharp edges.  
HIGH risk.

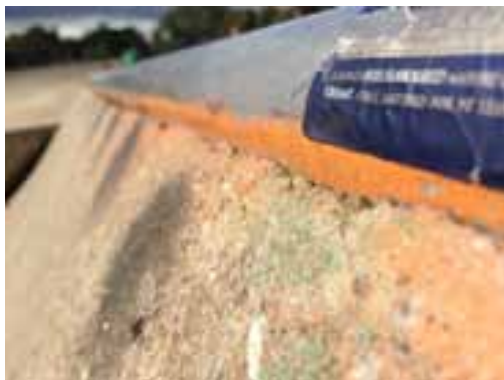
The concrete is receding from beneath the copings. This will deteriorate over time, especially due to frost action. The label should be removed.  
LOW risk.

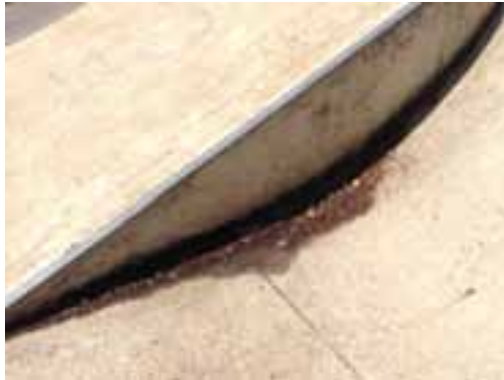
Some debris has accumulated between the flat and the transition that should be swept clear.  
MEDIUM risk.

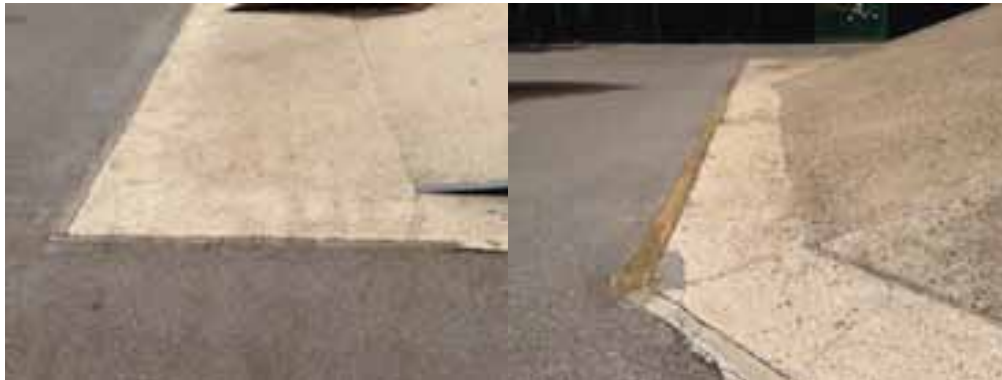
The concrete infill at the foot creates an uneven riding surface and will deteriorate to create distinct tripping points. There is already one section missing giving a significant trip point.  
HIGH risk.

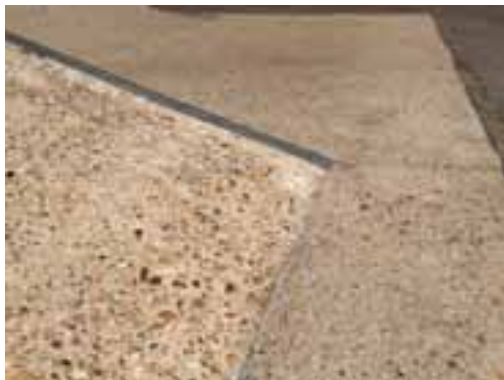
The angle between the flat and the ground is abrupt.  
HIGH risk.

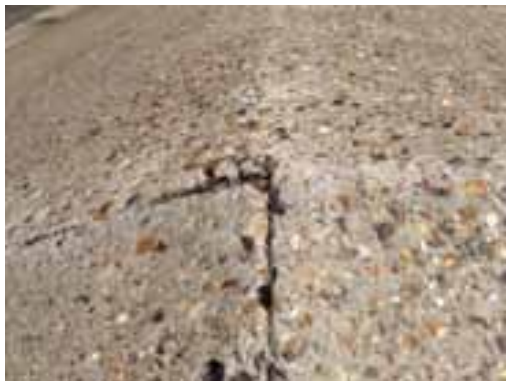
The concrete has a joint along the top of the flat, which creates an uneven riding surface and will deteriorate over time, especially with frost action.  
MEDIUM risk.

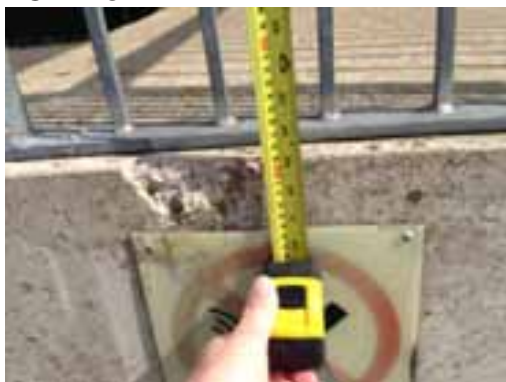
The barriers are less than the required 1200 mm high.  
LOW risk.

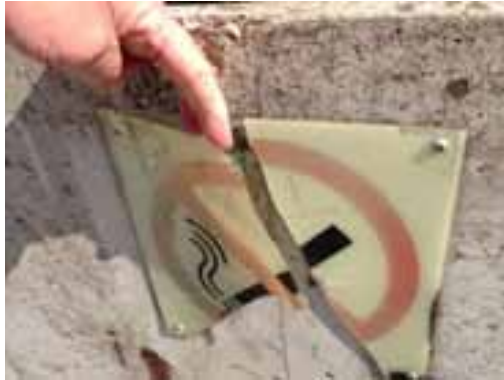
The attached no smoking sign is damaged presenting a puncture injury risk.  
MEDIUM risk.

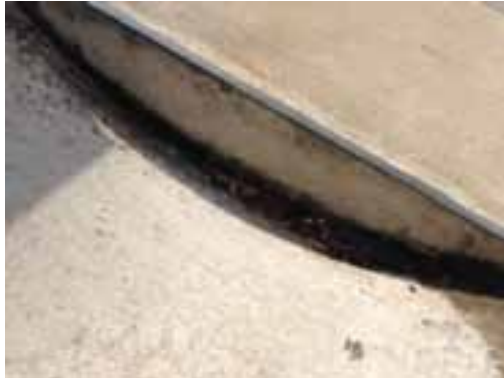
Some debris has accumulated between the flat and the transition that should be swept clear.  
MEDIUM risk.

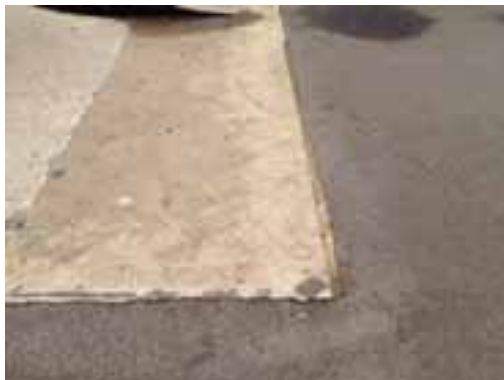
The concrete infill at the foot creates an uneven riding surface and will deteriorate to create distinct tripping points. There is already one section missing giving a significant trip point.  
HIGH risk.

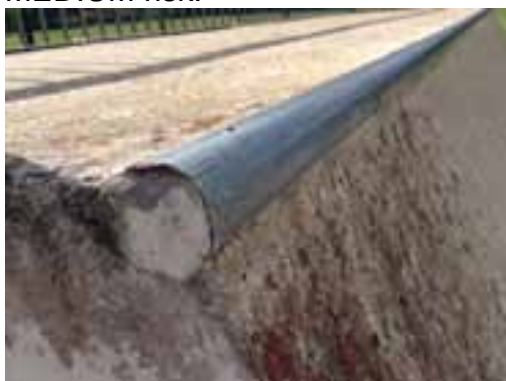
The coping ends are not rounded with a radius of minimum 3 mm.  
MEDIUM risk.

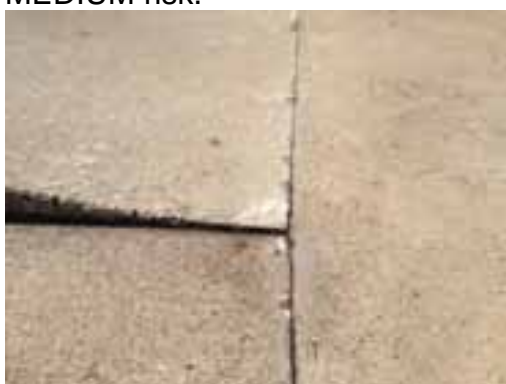
The foot is raised, giving an uneven riding surface.  
MEDIUM risk.

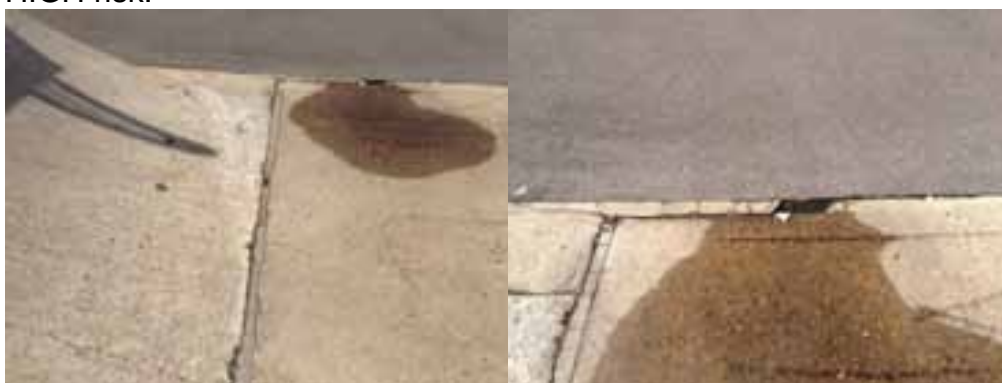
The concrete infill at the foot creates an uneven riding surface and will deteriorate to create distinct tripping points. There is already one section missing.  
HIGH risk.

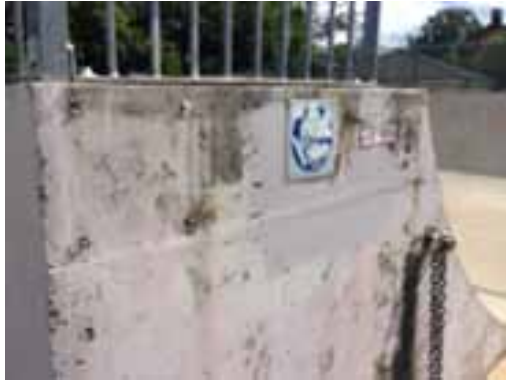
Protruding screw heads to the side where a sign has been removed.  
LOW risk.

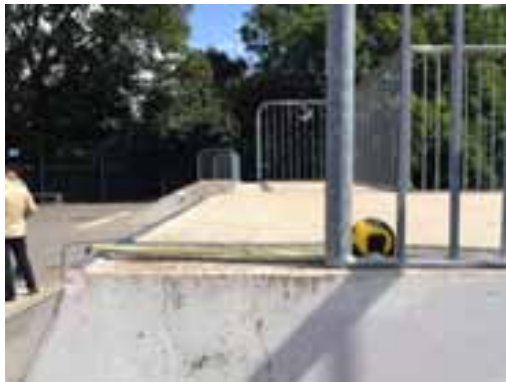
The spacing between the barrier front and the coping is excessive.  
LOW risk.

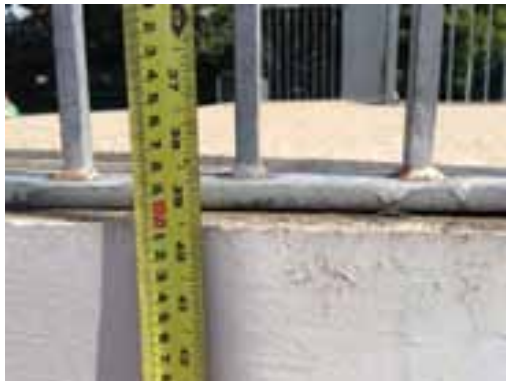
The barriers are less than the required 1200 mm high.  
LOW risk.

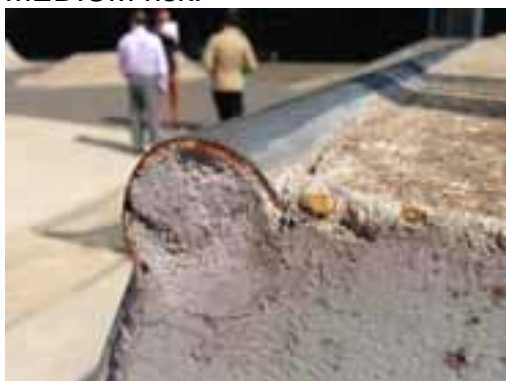
The coping ends are not rounded with a radius of minimum 3 mm.  
MEDIUM risk.

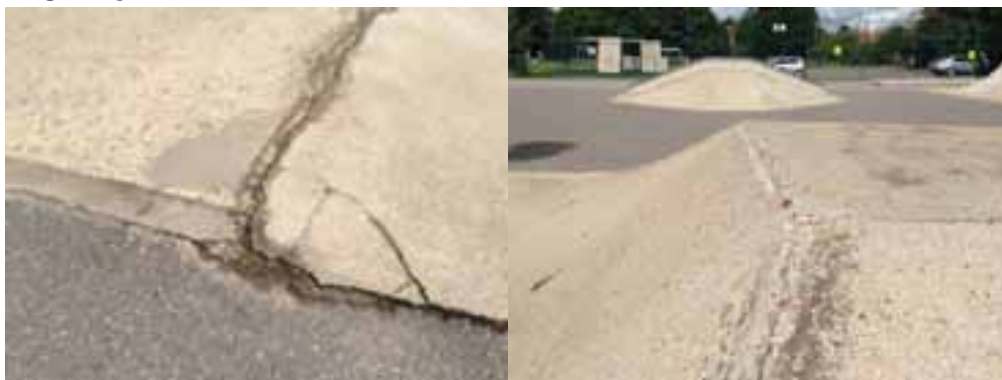
There are gaps between sections which present uneven riding surfaces, which will deteriorate over time especially with frost action.

HIGH risk.

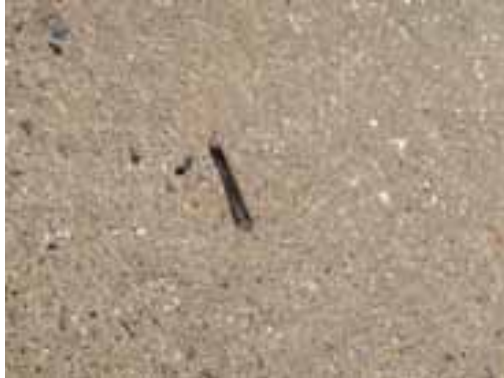
Timber fragment is showing in the concrete, indicating a poor concrete mix. More generally, the concrete presents a rough surface to riders, making riding difficult and falls potentially more painful than necessary. This applies to all concrete on site.

**MEDIUM risk.**

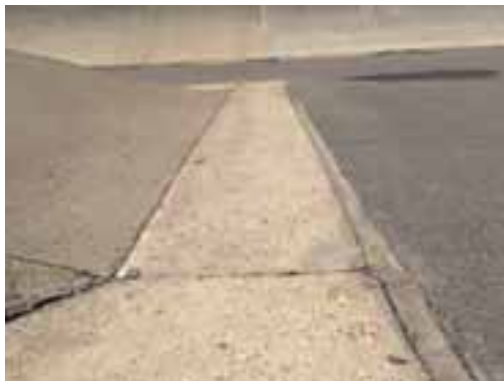
The concrete infill at the foot creates an uneven riding surface and will deteriorate to create distinct tripping points. There is already one section missing.

**HIGH risk.**

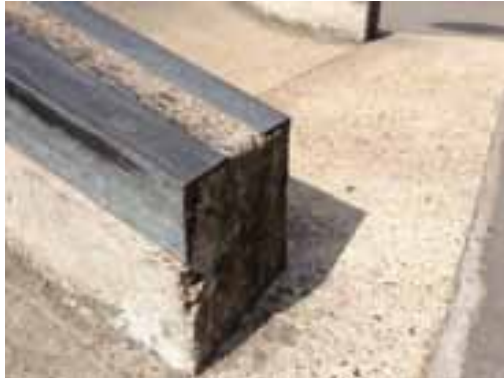
The rail ends are not rounded with a minimum of 3 mm radius.  
HIGH risk.

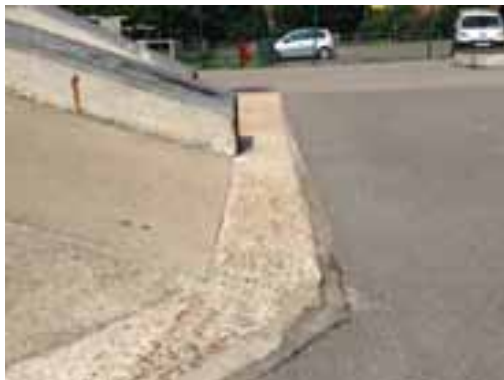
The concrete infill at the foot creates an uneven riding surface and will deteriorate to create distinct tripping points.

MEDIUM risk.

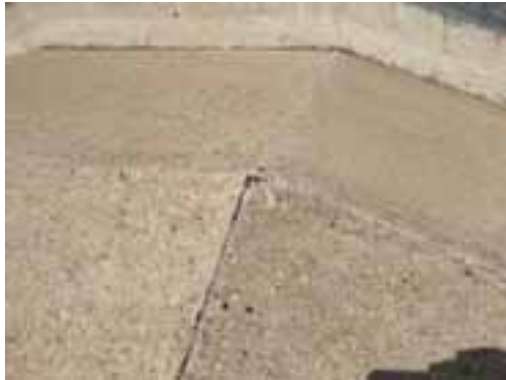
There are gaps between sections which present uneven riding surfaces, which will deteriorate over time especially with frost action.  
MEDIUM risk.

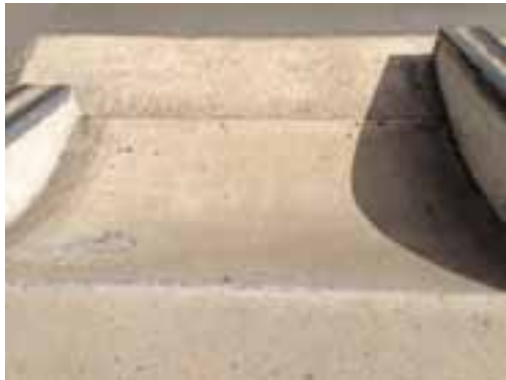
The curvature of one transition is uneven, creating unpredictable riding.  
HIGH risk.

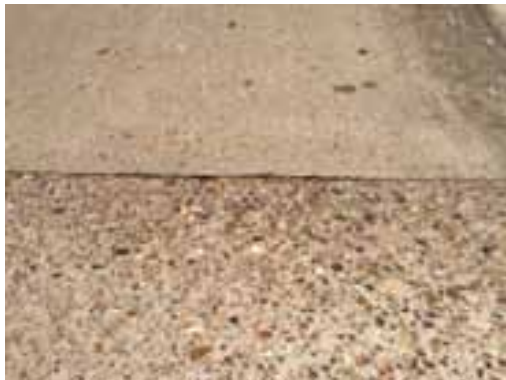
The change between rough and less rough surfaces creates an unexpected change.  
MEDIUM risk.

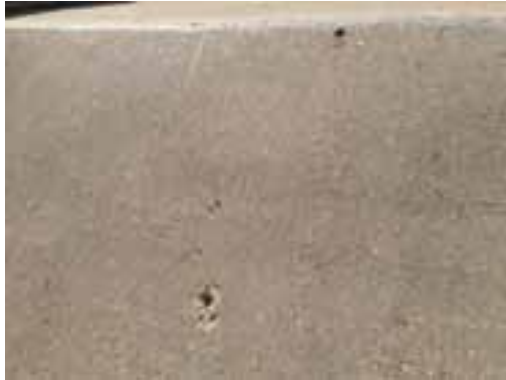
There are holes in the concrete which presents an uneven riding surface.  
MEDIUM risk.
