## Safety Inspection Report

On behalf of: Freestyle Skateparks  
Site Name: Croxley Green Skatepark  
Date of Inspection: 22 August 2014  
Inspector: David Yearley

This report has been commissioned by Freestyle Skateparks to assess the condition and safety of the existing skatepark at Croxley Green.

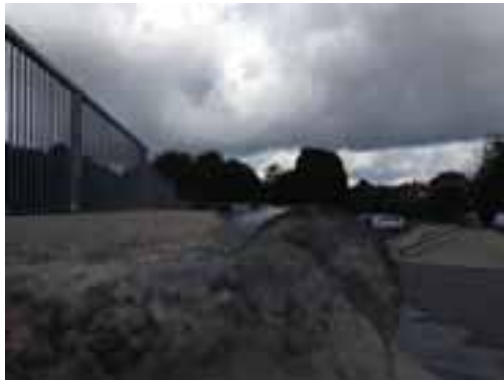
The coping upstand in measured to be in excess of 12 mm at one end,  
potentially leading to difficulty for skateboarders.  
MEDIUM risk.

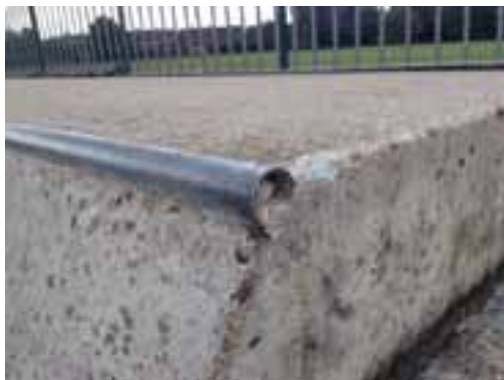
The coping end is not sealed at the end.  
LOW risk.

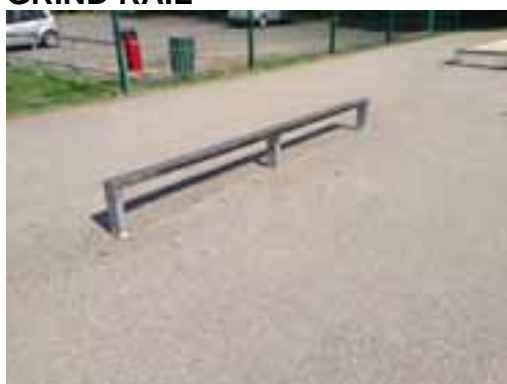
### GRIND RAIL

The rail is in good condition. It presents a HIGH risk due to the nature of the sport.

The rail ends are not rounded contrary to EN 14974, but the non-rounded rails provide a better riding experience and do not require modification.

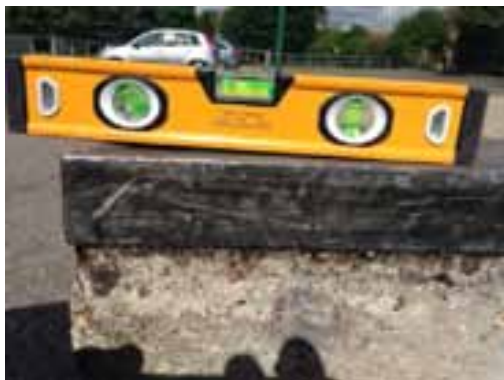
Uneven section at one corner makes for difficult or unpredictable grinding.  
HIGH risk.

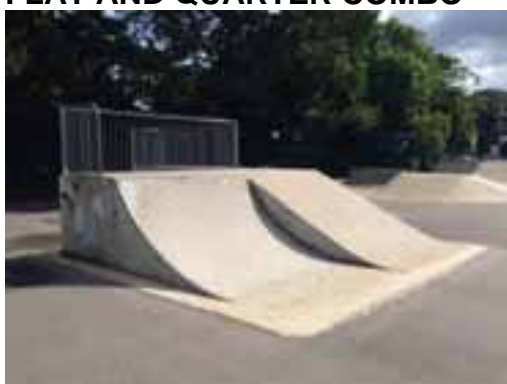
### **FLAT AND QUARTER COMBO**

This unit is in fair condition and presents a HIGH risk to users due to the nature of the sport.

The void space behind the unit has an accumulation of debris which may find its way to the riding surfaces.

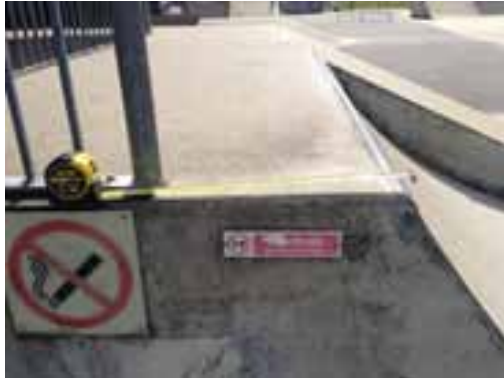
The spacing between the barrier front and the coping is excessive.  
LOW risk.

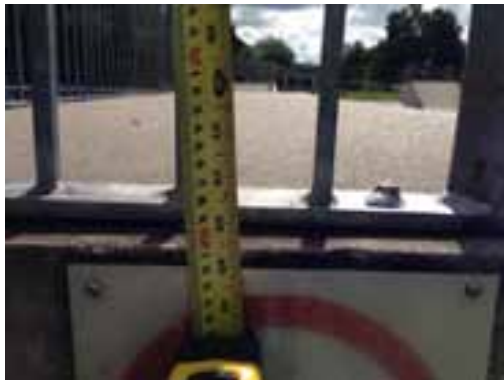
The barriers are less than the required 1200 mm high.  
LOW risk.

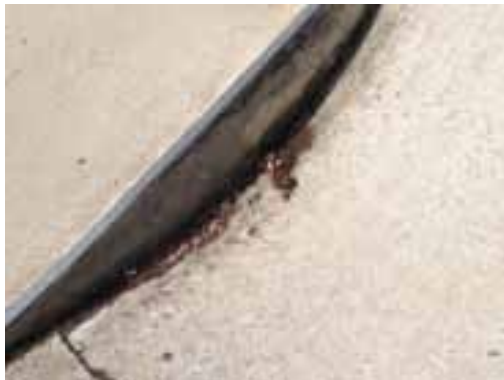
Some debris has accumulated between the flat and the transition that should be swept clear.  
MEDIUM risk.

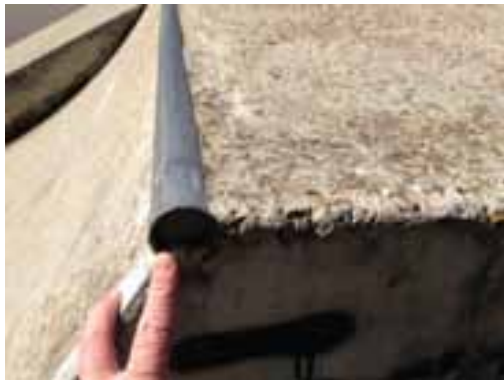
The coping end is not sealed.  
LOW risk.

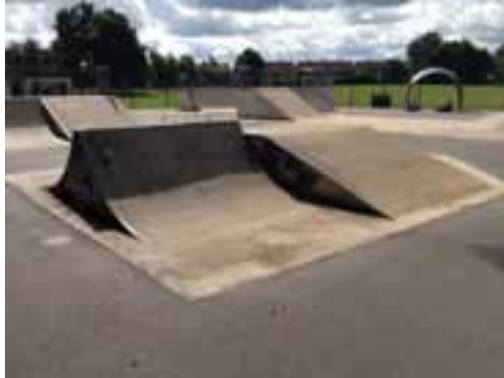
## SPINE AND JUMP BOX

This unit is in fair condition and presents a HIGH risk to users due to the nature of the sport.

The coping ends are non-rounded and have sharp edges.  
HIGH risk.

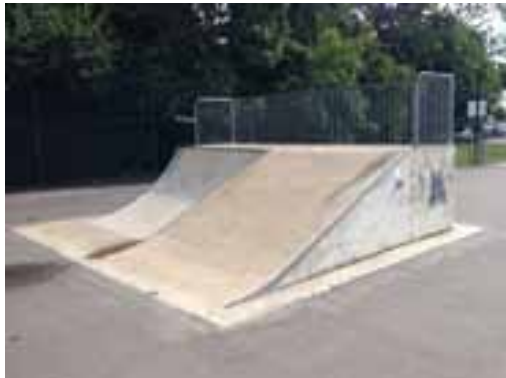
### FLAT AND QUARTER COMBO

This unit is in fair condition and presents a HIGH risk to users due to the nature of the sport.

The barriers are less than the required 1200 mm high.  
LOW risk.

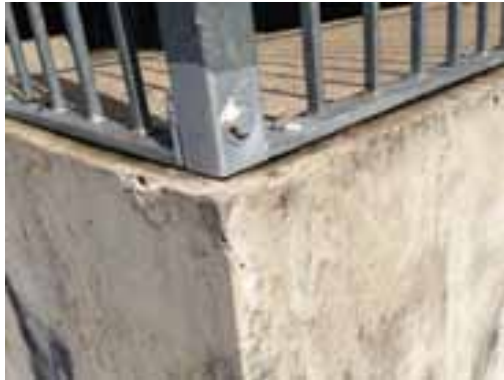
The concrete edges are not rounded.  
MEDIUM risk.

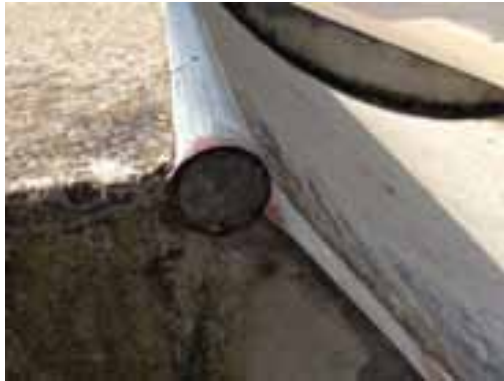
The coping ends are not rounded.  
MEDIUM risk.

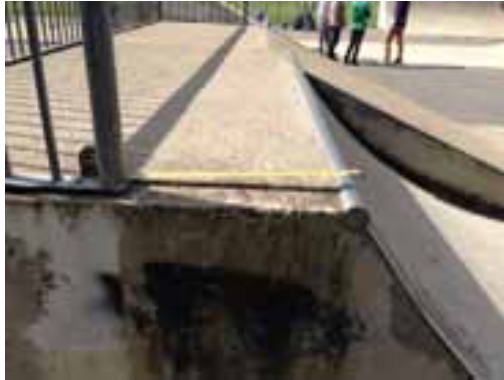
The spacing between the barrier front and the coping is excessive.  
LOW risk.

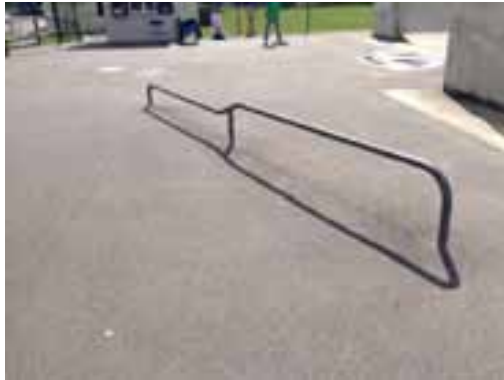
### GRIND RAIL

This unit is in good condition and presents a HIGH risk to users due to the nature of the sport.

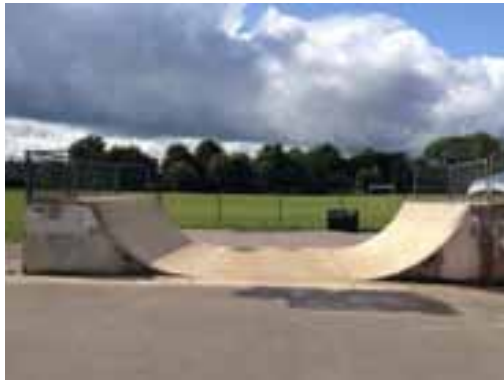
### MINI PIPE

This unit is in fair condition and presents a HIGH risk to users due to the nature of the sport.

The barriers are less than the required 1200 mm high.

LOW risk.

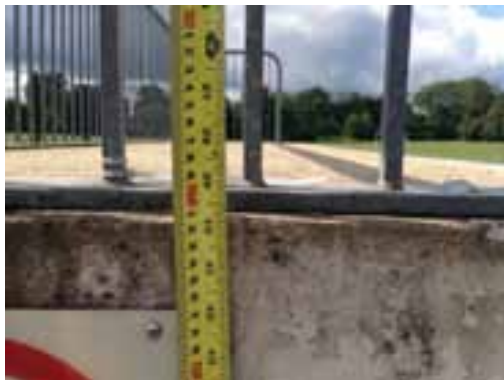
The coping ends are not rounded with a radius of minimum 3 mm.  
MEDIUM risk.

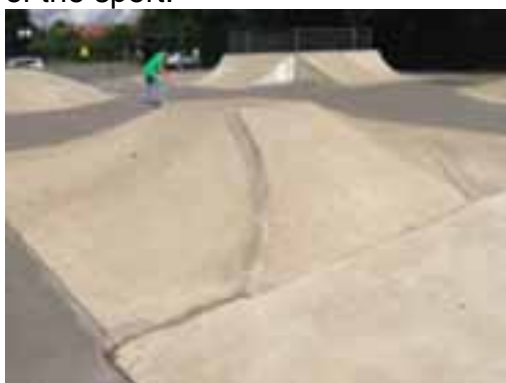
### **PYRAMID**

This unit is in poor condition and presents a HIGH risk to users due the nature of the sport.

There are gaps between sections which present uneven riding surfaces, which will deteriorate over time especially with frost action.

HIGH risk.

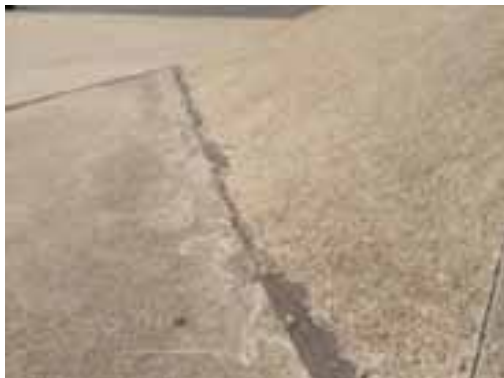
The angle between the flat and the ground is abrupt.

**HIGH risk.**

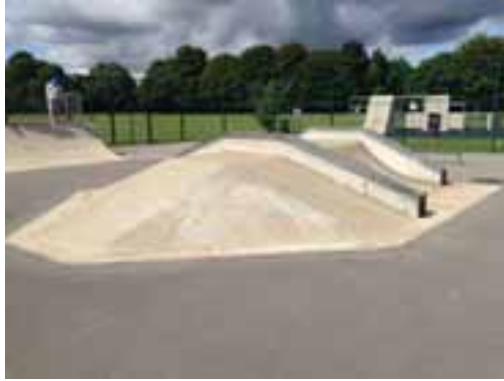
## FUNBOX

This unit is in fair condition and presents a HIGH risk to users due to the nature of the sport.

The rail ends are not rounded with a minimum of 3 mm radius.  
HIGH risk.
